# 30<sup>th</sup> RCI International Convention and Trade Show

## GLAZING FAILURES AND WAYS TO PREVENT THEM

**BRIAN HUBBS, PENG, AND JAMES HIGGINS**

*RDH BUILDING ENGINEERING LTD.*

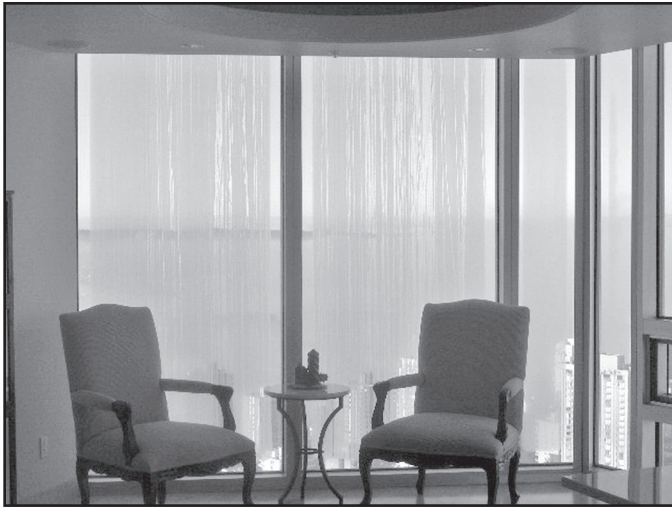
**Figure 3 – Significant IGU condensation visible from the interior.**

Since completion in 2001, the building experienced issues related to the IGU performance, including window condensation and corrosion of the low-e-coating within the glazing units (*Figure 3*). The issues continued for years despite ongoing attempted repairs by the original curtain wall manufacturer.

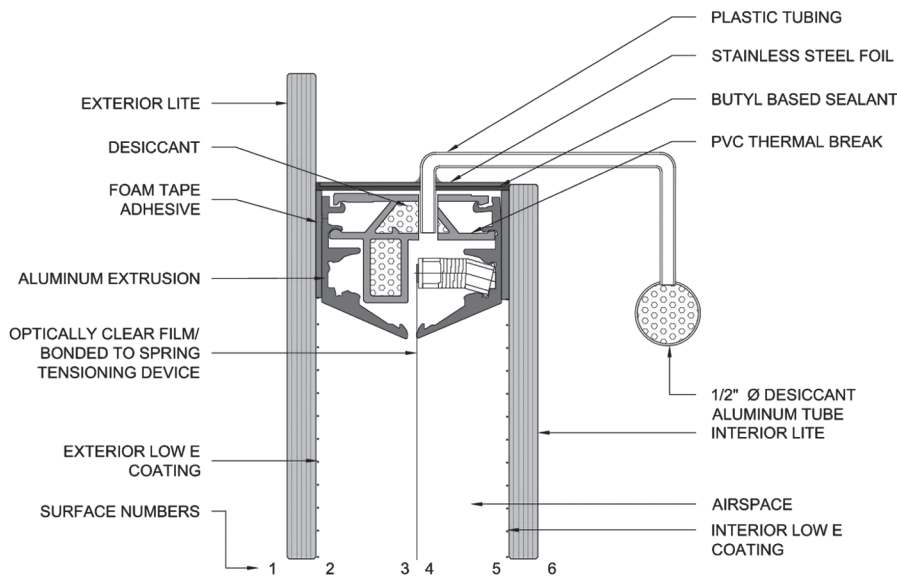
The authors completed an extensive investigation to understand the failure mechanism. Initial review of the proprietary IGU edge spacer design (*Figure 4*) showed where the innovative design may be prone to premature failure.

**Figure 4 – Schematic drawing of the proprietary IGU edge spacer design.**

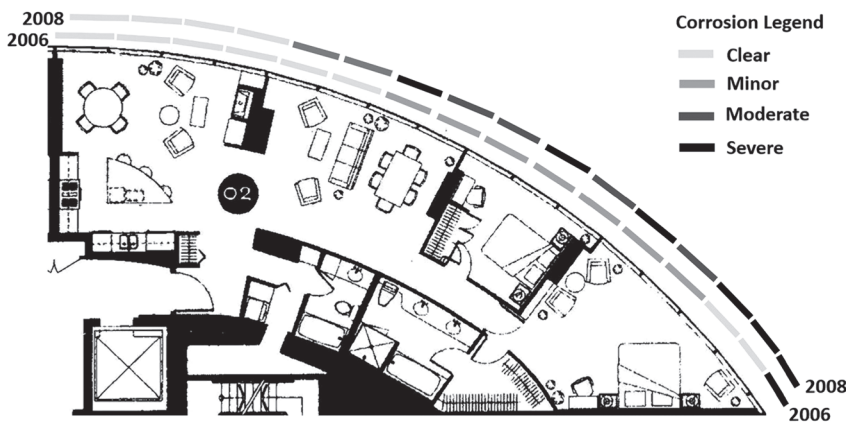
**Figure 5 – Results showing the correlation of visual condition and dew point as well as an indication of the rate of deterioration.**

It was found that the visual clarity of the IGUs on the building was worsening and had deteriorated to unacceptable levels on many units. The deterioration of the visual quality of the IGUs is a result of condensation and the related low-e coating corrosion inside the IGU, which correlated well with the dew point measured inside the IGU (see Figure 5).

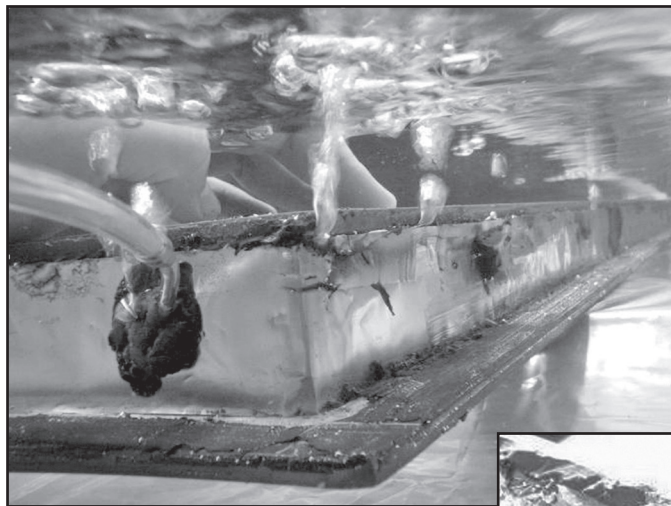
**Figure 6 – Typical ridges in metal banding caused by repetitive thermal expansion and contraction of metal film over thermoplastic sealant.**

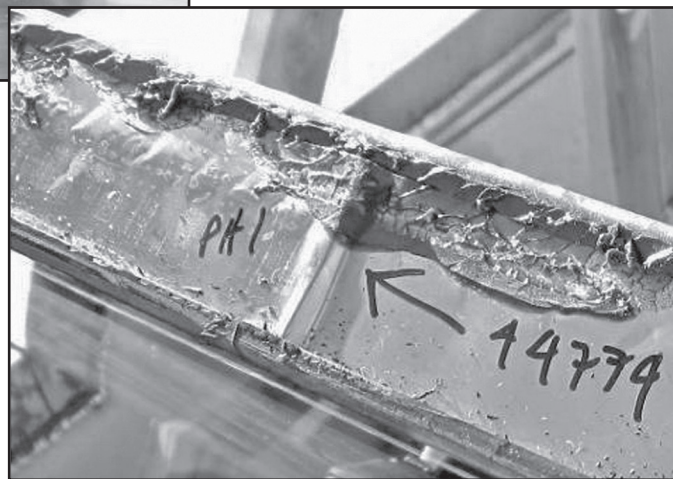
The condensation was found to be caused by a buildup of moisture inside the IGU as a result of temperature changes, pressure differences across the enclosure, and fluctuations in barometric pressure forcing moist exterior or interior air through discontinuities in the perimeter seal (shown in Figure 6 and Figure 7). Three air leakage mechanisms were found to contribute to this moisture buildup:

**Figure 7 – Submerged IGU showing air leakage (bubbles) at ridges and discontinuities in the edge seal.**

Therefore, even a very large desiccant tube attached to the existing tubing would not have any appreciable effect on reducing the moisture inside the IGU. It was determined through the course of the IGU failure investigation that the only reliable repair strategy to address the fogging and corroding surfaces in the IGUs was to replace the IGUs.

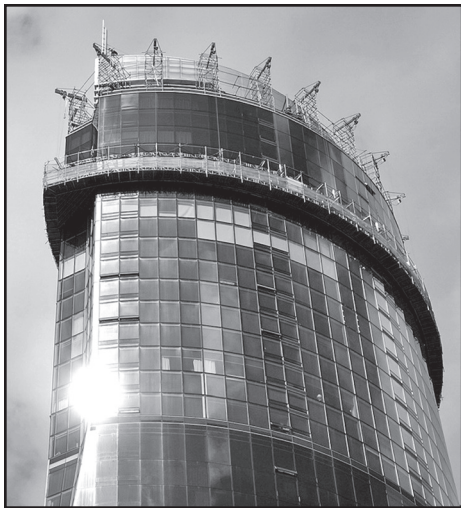
**Figure 8 – High-rise tower showing a portion of the completed IGU replacement and the custom suspended scaffolding ring.**

The four-sided structurally glazed curtain wall system posed several reglazing challenges to the design and construction team. The original IGUs relied on a single bead of silicone between the exterior lite and the curtain wall frame to fasten the entire unit to the building. This sealant bead was installed in an environmentally controlled plant, on an accessible horizontal surface from the edge of the glass once the IGU was placed in the framing. In addition, stringent in-plant quality control procedures were in place. On site, there is no direct access to the edge of the IGU to allow the application of structural sealant after the unit is installed. The work also needed to be performed off swing stages exposed to Vancouver weather. As a result, a hybrid structurally glazed and mechanically attached system was used to reglaze the building, and a continuous stage was

designed to wrap the entire building to increase the wind resistance of the work platform and reduce the amount of tieback required (see *Figure 8*).

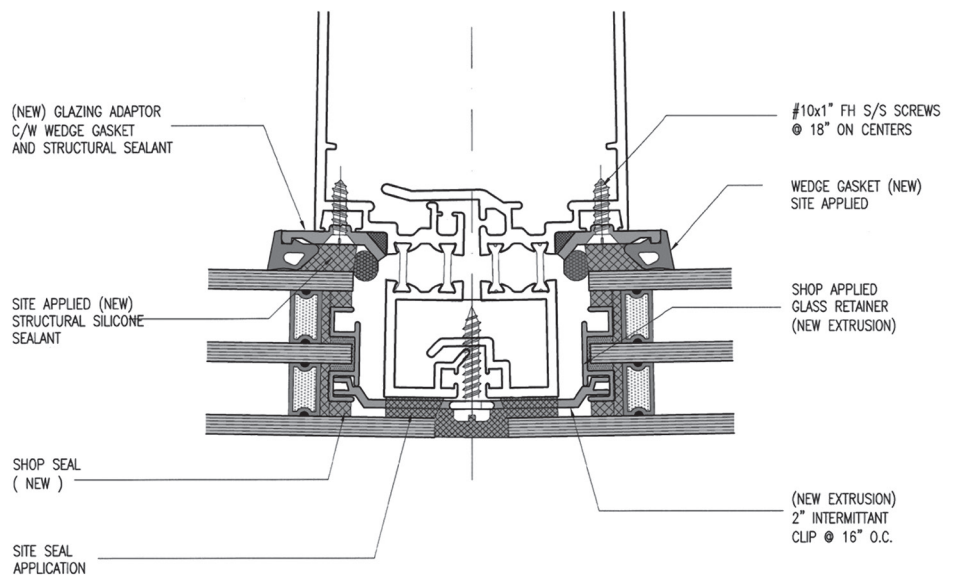
**Figure 9 – Hybrid glazing system utilizing factory-applied mechanical fasteners and field-applied structural glazing.**

The concept for the mechanically attached four-sided structural glazing is shown in *Figure 9* with a conventional triple-glazed IGU.

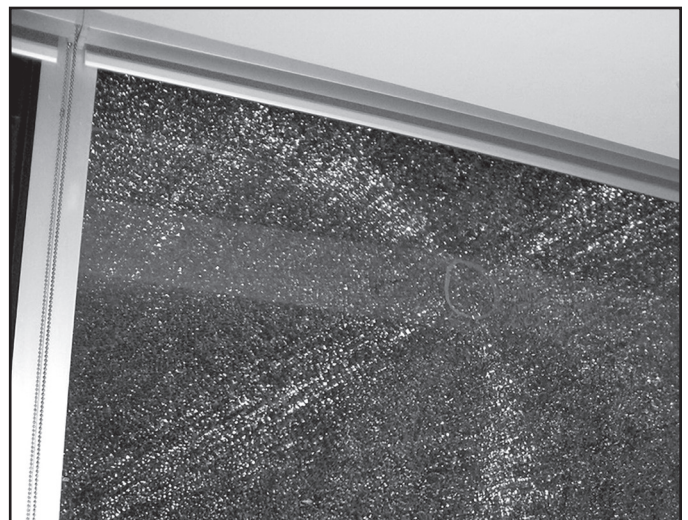
**Figure 10 – Typical spontaneous glass breakage.**

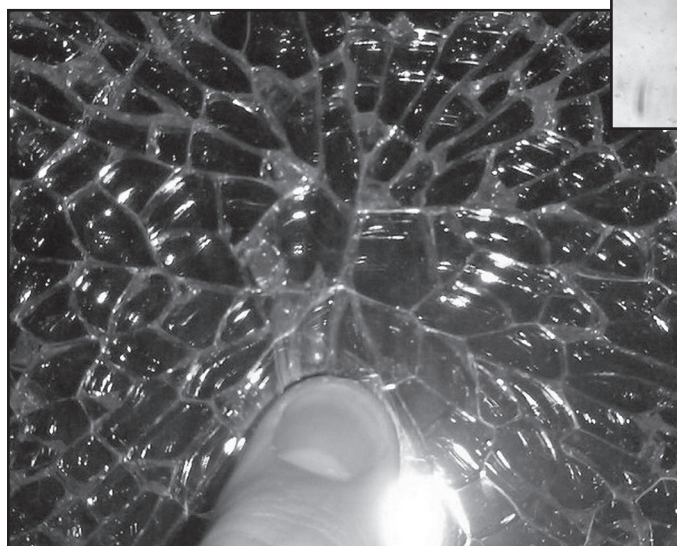
**Figure 11 – Typical butterfly pattern at the epicenter of the break with magnified NiS inclusion inset (right).**

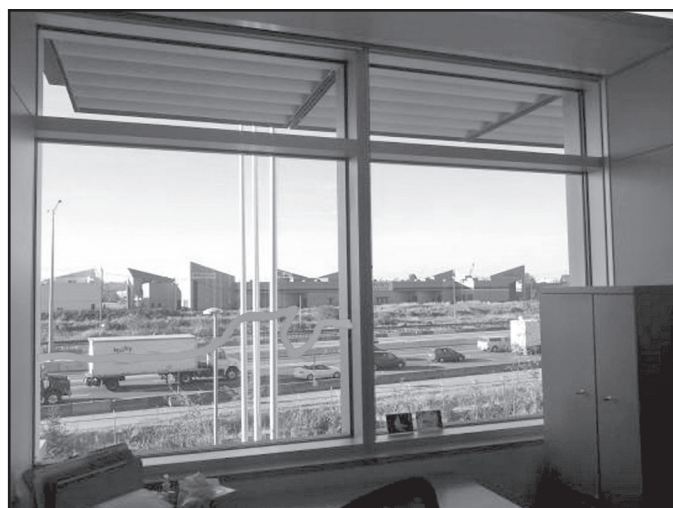
On a six-month-old building in Vancouver, BC, the owners reported a number of broken windows without an apparent physical cause. The building had exterior solar shades, and IGUs consisted of annealed glass with a solar-selective, low-e coating on surface #2. All cracks were found to intersect with edges at 90 degrees (Figure 12). When the units were replaced, the installation was reviewed and the edges were found to be undamaged and units properly glazed. It was determined that the breakage was caused by thermal stress fractures. The owner was informed that more thermal stress breaks should be expected and that all replacement units should be heat-strengthened to prevent thermal stress fractures in the future.

**Figure 12 – Typical thermal stress break caused by solar shades partially shading annealed glass. Note that the break pattern starts and stops at 90 degrees to the edge.**

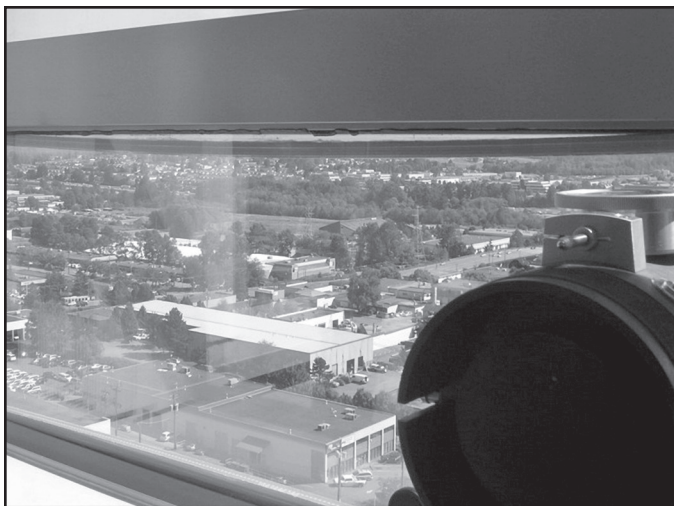
**Figure 13 – Displacement of spacer bar and seal into vision area after 10 years in service.**

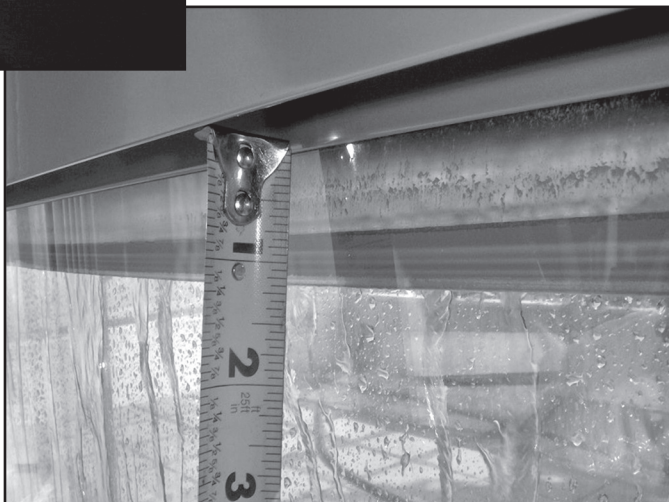
On one building in Vancouver, BC (elevation 200 feet), the windows and IGUs were manufactured and sealed in Edmonton, AB (elevation 2,191 feet), creating a suction pressure inside the unit once installed. The IGUs were double-glazed, utilizing an aluminum spacer bar and a single thermoplastic sealant. Thermoplastic sealants

**Figure 14 – Large deflections up to 1.25 in. occurred on the long edge of the smaller IGUs due to the increased pressures created.**

such as hot-melt butyl behave elastically at some temperatures and can flow at high temperatures. After 10 years in service, the spacer bars had all displaced into the vision area (see Figure 13) as a result of the constant negative pressure in combination with very slow creep of the edge sealant during warm temperature cycles. The amount of displacement was correlated to the size of the units, with the highest displacement occurring on the smaller units with high aspect ratios, as shown in Figure 14.

To reduce the risk of spacer bar deflection, a dual seal can be utilized in the construction of the IGU. A conventional

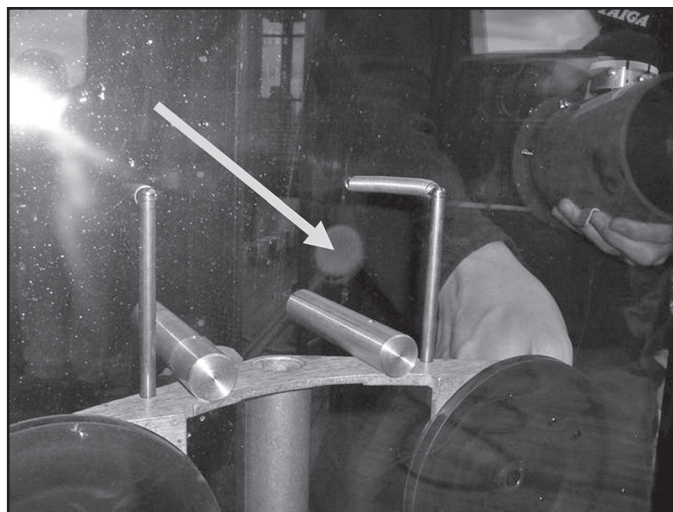
On a five-year-old building in Portland, OR, owners complained of dust and fingerprints on their windows that could not be removed by cleaning. When these observations were reviewed in the field, it was found that the dust and fingerprints reported were actually corrosion of the low e-coating on surface 2 of the IGU. As a result of this finding, a sample of units

was tested to determine the dew point temperature (see Figure 15). It was found that all units exhibiting corrosion of the low-e coating had dew points greater than  $-5^{\circ}\text{C}$

**Figure 15 – Complaints of dirt build-up and fingerings on the inside of IGUs prompted dew point testing, which revealed high levels of moisture inside the units.**

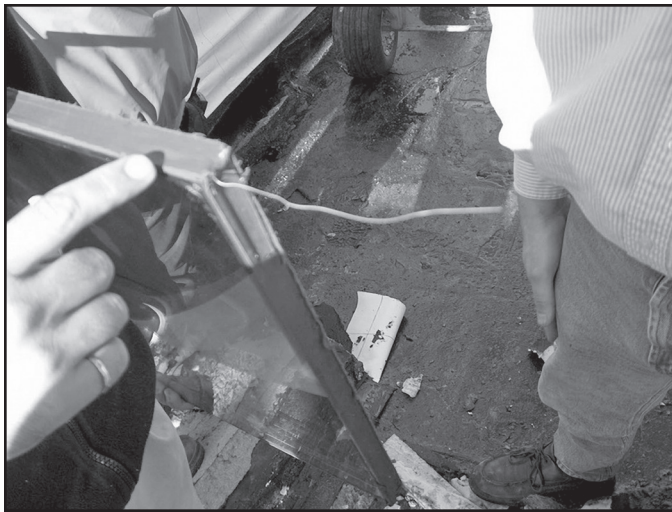
**Figure 16 – The culprit was unsealed capillary tubes concealed within the window assembly.**

As shown in *Figure 16*, unsealed capillary tubes were found on all units with high dew points. To reduce the risk of IGU failure, always ensure that capillary and vent tubes are properly sealed when installed into the glazing system or once the product arrives on site.

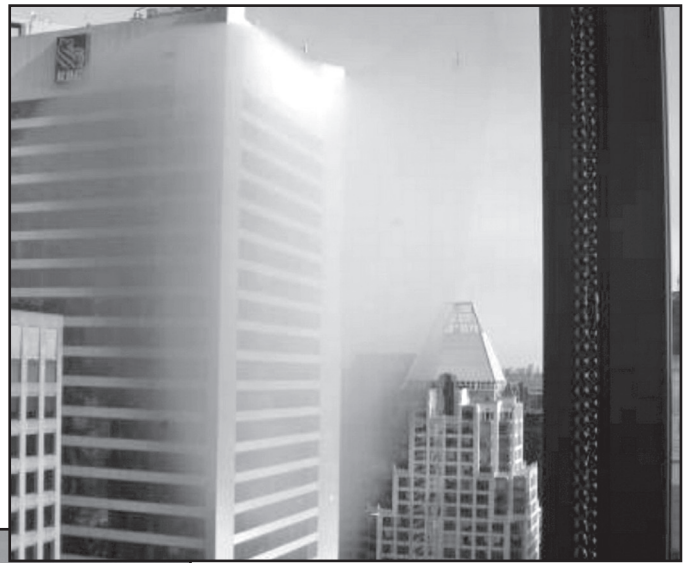
**Figure 17 – Volatile fogging during a period of warm weather on a one-year-old IGU.**

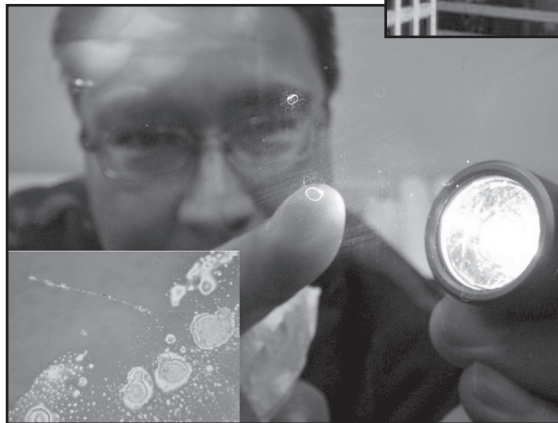
**Figure 18 – One of the authors examining damage to low-e coatings caused by volatile fogging and condensation fogging. Same location under magnification shows corrosion pattern (inset).**

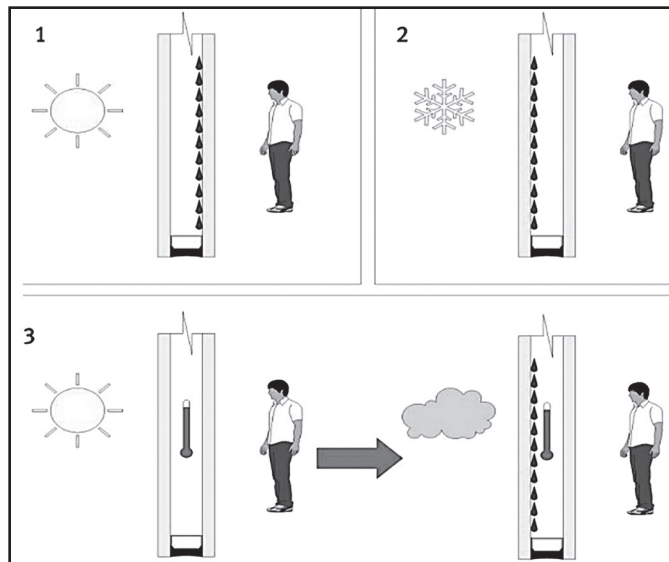
**Figure 19 – Volatile fogging (1), moisture condensation fogging (2), volatile fogging and/or moisture condensation (3).**

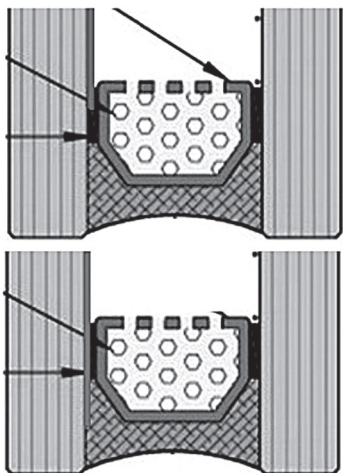
**Figure 23 – Typical versus incomplete edge deletion.**

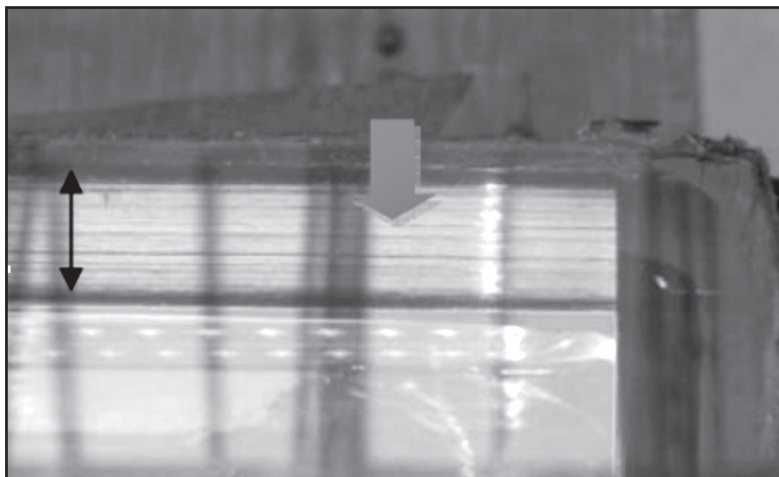
Insulated glass units are manufactured from two or more layers of glass that are separated by a spacer bar and hermetically sealed with various sealants. In order for the sealants to adhere to the glass, moisture-sensitive coatings need to be fully removed or edge-deleted where the sealant is in contact with the glass so that the sealants can bond directly to the glass (see Figure 23). Many low-e coatings contain layers of reactive metals (such as silver) that can affect the bond over time if exposed to moisture or chemicals in the adjacent sealants or setting blocks. Signs of incomplete edge deletion are easy to spot as a reflective residue along the sealant bond line, as shown in Figure 24.

**Figure 24 – Incomplete edge deletion on a new IGU made apparent by the reflective residue.**

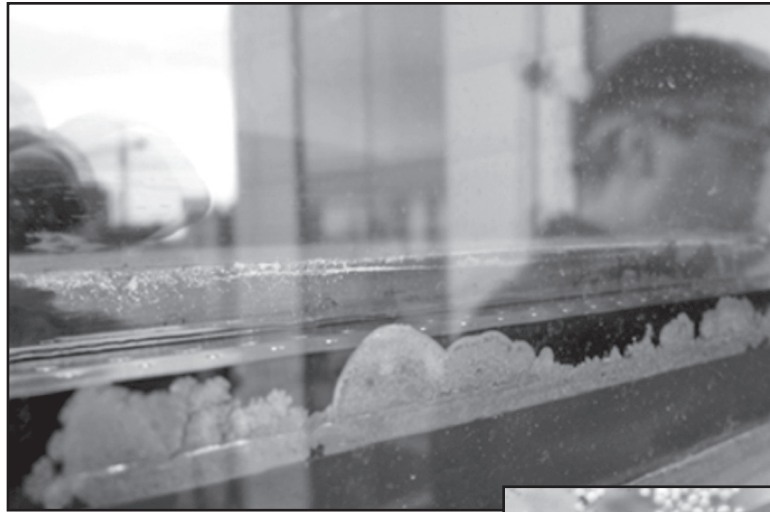
**Figure 25 – Corrosion of partially edge-deleted low-e coating.**

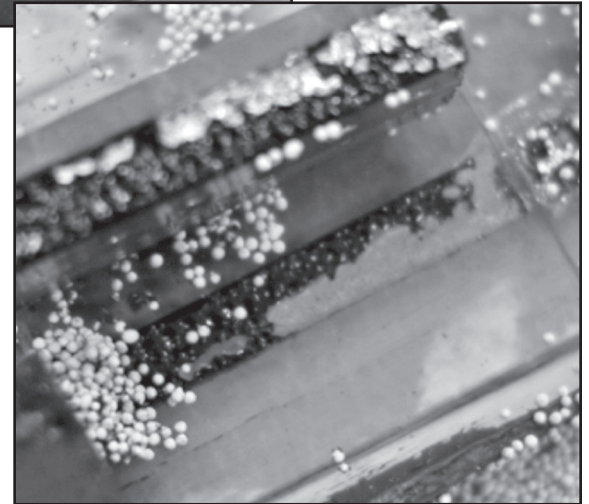
**Figure 26 – Low-e corrosion residue left on IGU sealant after pull test showing loss of adhesion.**

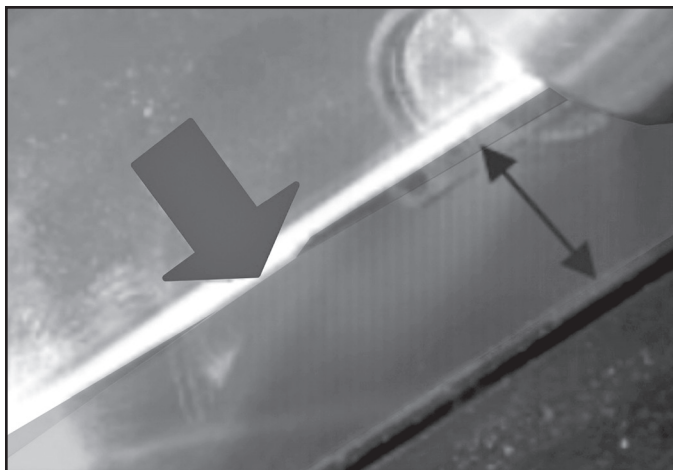
**Figure 27 – Visual review of a completed edge seal revealing a gap in the primary seal (lower arrow) and a continuous secondary seal (upper arrow).**

in the event of small manufacturing defects. For larger units in high-rise construction, dual-sealed systems leveraging the vapor resistance and watertightness of polyisobutylene for the primary seal and the water resistance, durability, and structural strength of silicone are some of the best-performing systems, provided both seals are continuous (see Figure 27).

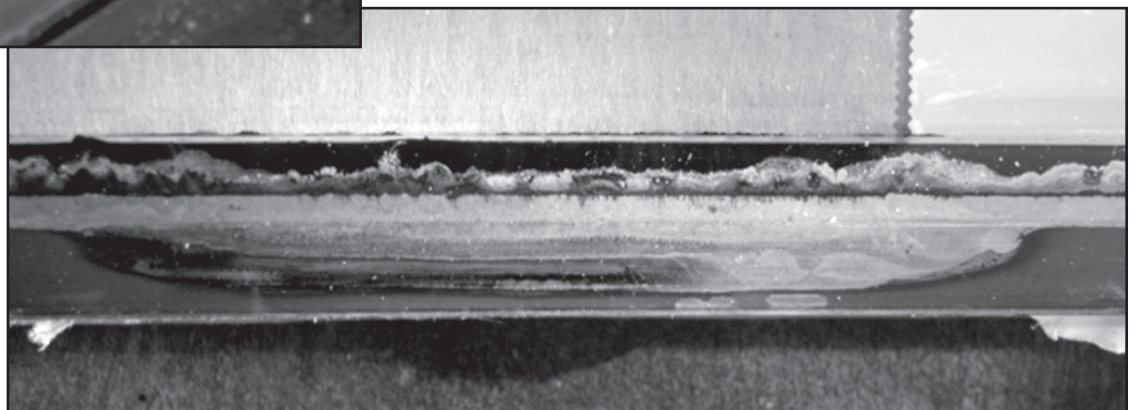
**Figure 28 – View of the bottom of the IGU showing damage to a silicone IGU edge seal caused by setting block incompatibility.**

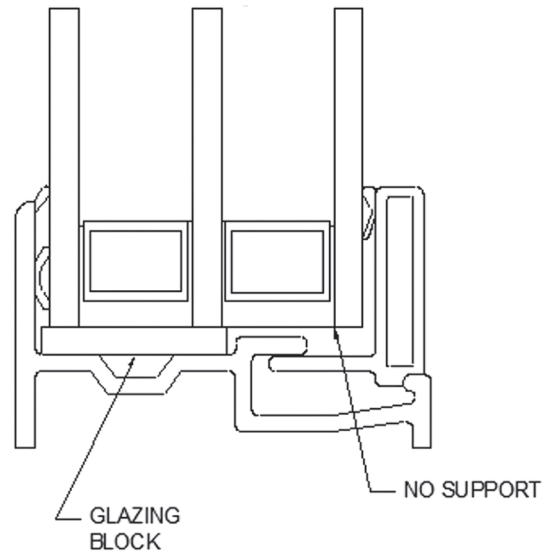
**Figure 30 – Typical legacy window system modified to utilize triple glazing without consideration of good glazing practices. From IGMA TM1500.**

With the more frequent specification of triple glazing, even support of glazing lites can often be difficult with legacy framing systems that have been designed around thinner double glazing (Figures 29 and 30). It is important to check to ensure specified glazing streams can support the use of triple glazing installed in accordance with IGMA TM1500 before selecting a glazing manufacturer.
