CURTAINWALL FAILURES – DESIGN OR PRODUCTS

BUILDING ENVELOPE TECHNOLOGY SYMPOSIUM

CURTAINWALL FAILURES — DESIGN OR PRODUCTS

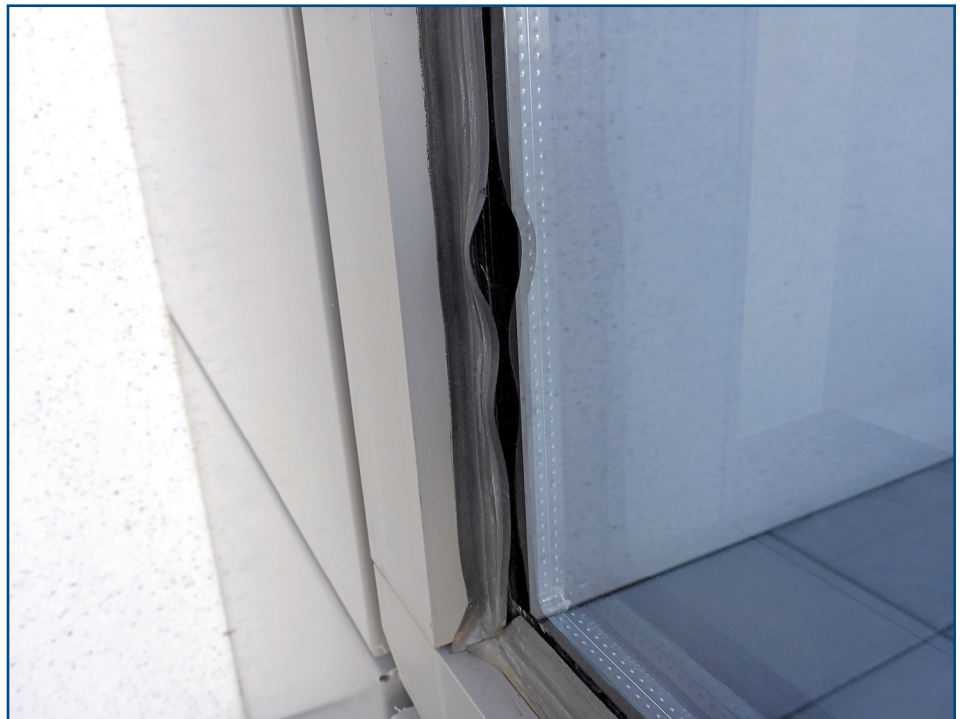
Figure 3 – Example of gasketing failure.

As gaskets age, they begin to dry out, shrink, and crack. The elastic material degrades when subjected to ultraviolet radiation and freeze-thaw cycles, much like an old rubber band. At first, air spaces are created by the shrinking, dried gaskets, which admit air and moisture into the system

(Figure 3). This can lead to condensation, drafts, and leaks. As the gaskets further disintegrate, they may loosen and pull away from the frame. Without the support of flexible gaskets, the glass loses stability and may shatter or blow out. For this reason, it is important to maintain and routinely replace gaskets to keep the curtainwall system operational and safe.

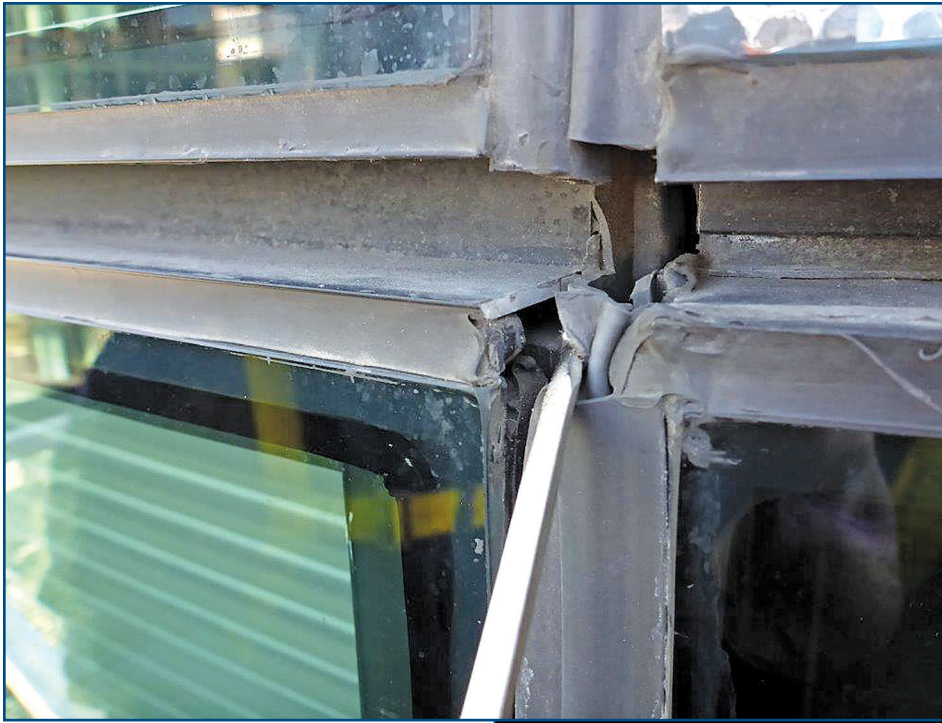
Figure 4 – Path of water intrusion over IGU glass edge.

In the case in *Figure 4*, seals were ineffectively executed or they degraded, allowing water to enter the glazing system and literally sit on top of the glass. As a result, water or water vapor permeated the silicone secondary seal and attacked the low-E coating (located on the inside surface of the exterior lite), causing glass corrosion.

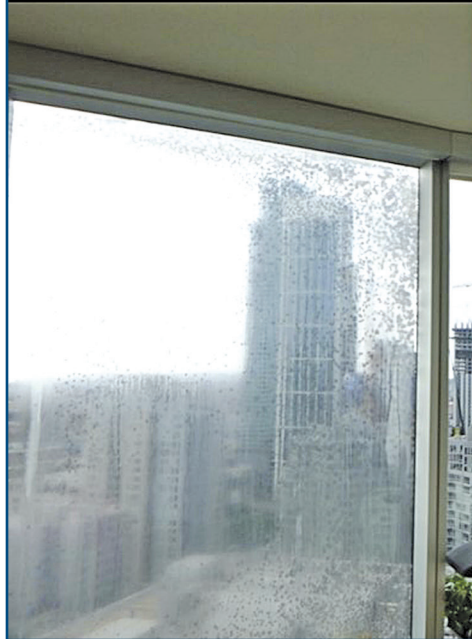
Figure 5 – Example of glass fogging in conjunction with low-E corrosion.

High-performance, low-E coatings are the most commonly used and have two or three layers of silver in addition to other metallic compounds. The black spots on a mirror are analogous to the corrosion seen in *Figure 5*.

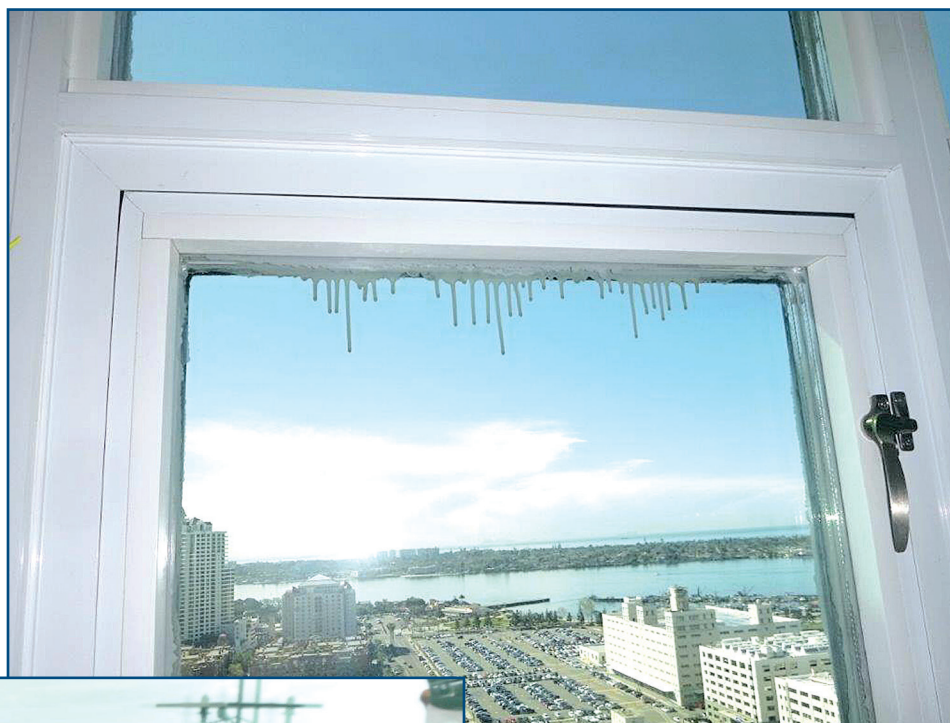
Figure 7 – Example of PIB migration.

PIB migration (*Figure 7*) leads to both a visually unappealing condition and a potentially serious reduction in the insulating glass unit longevity. There is no known remediation method, and the condition is, as far as we know, progressive. Over time, the migration will worsen, leading to a reduction in the service life of the IGU seal,

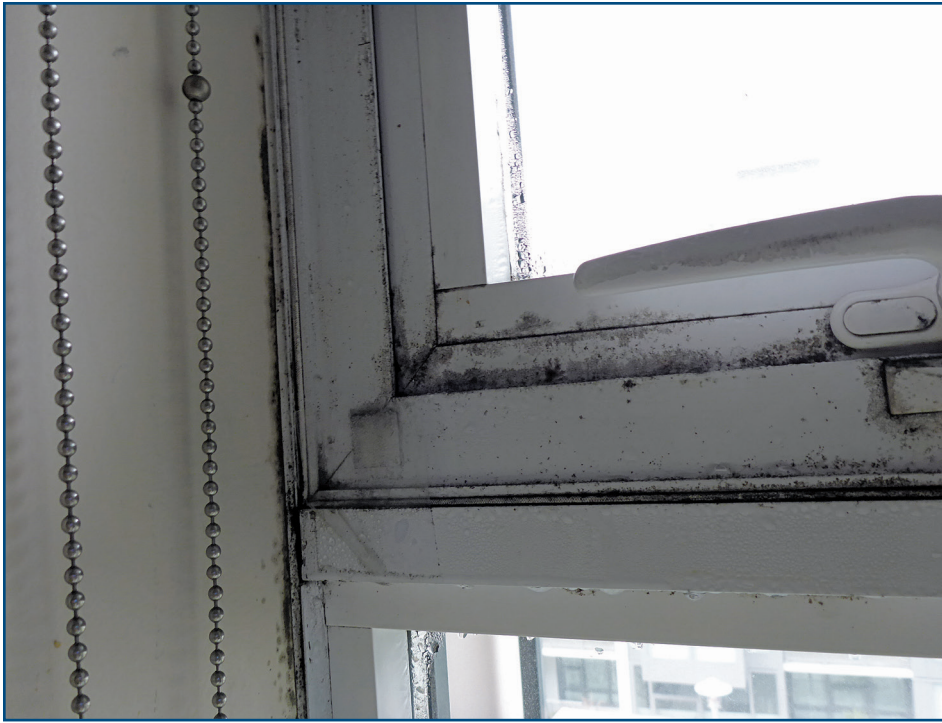
Figure 8 – Example of condensation failure.

Condensation occurs when the temperature of the glass or aluminum frame in a curtainwall reaches the dew point temperature of the interior space conditions. Water forms on the surface of the glass or aluminum and can cause damage to the interior finishes. Basic design against condensation ensures that the condensation resistance factor (CRF) of a given curtainwall section meets the requirement of the space, which is based on the expected temperature and humidity of the space. Designers should be aware that the CRF is an average and cannot account for cold spaces in the facility that can cause localized condensation (Figure 8).

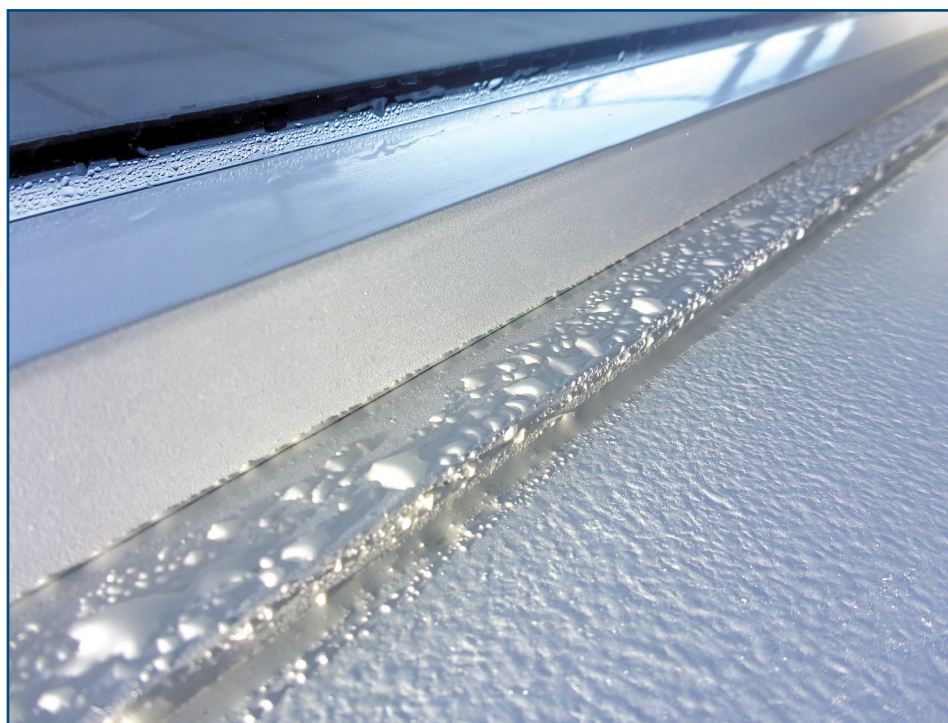
Figure 10 – Condensation on an interior window surface.

Condensation can be just as damaging to interior surfaces, such as drywall and wood trim, as water infiltration. In some cases, it appears that a window is leaking when, in fact, it is condensation. Design guidelines are particularly important for avoiding the creation of thermal bridges that will actually bypass the thermal breaks within a window system. As our detail in Figure 9 shows, even with a thermally broken aluminum window frame, factors like the method of attachment to the rough opening and under-functioning window components such as gasketing can cause exterior temperatures to be transferred to interior surfaces.

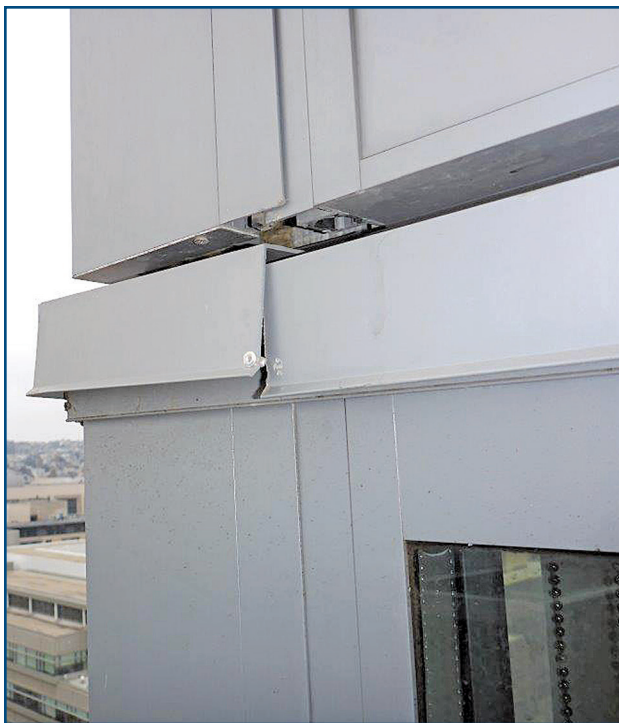
Figure 11 – Sample of trim cover failure.

without mechanical attachments. However, poor quality control of the products during the manufacturing process can provide potential problems in the long term. Dies used for extruding covers can wear out, resulting in poor fit and holding strength. Checking for tolerances and proper preparation and adhesion can be critical to long-term performance.

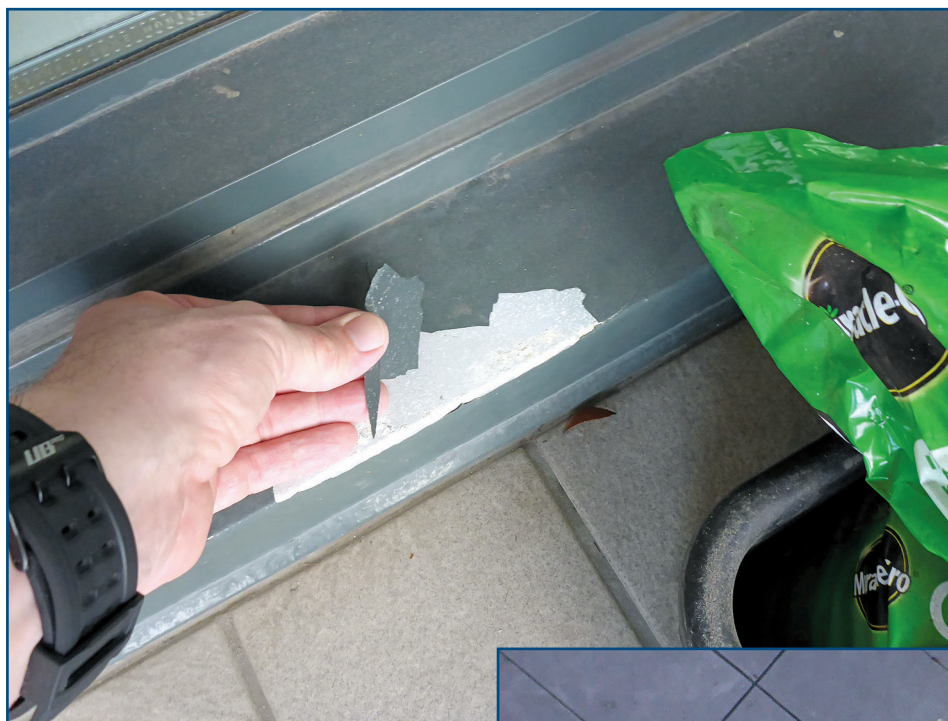
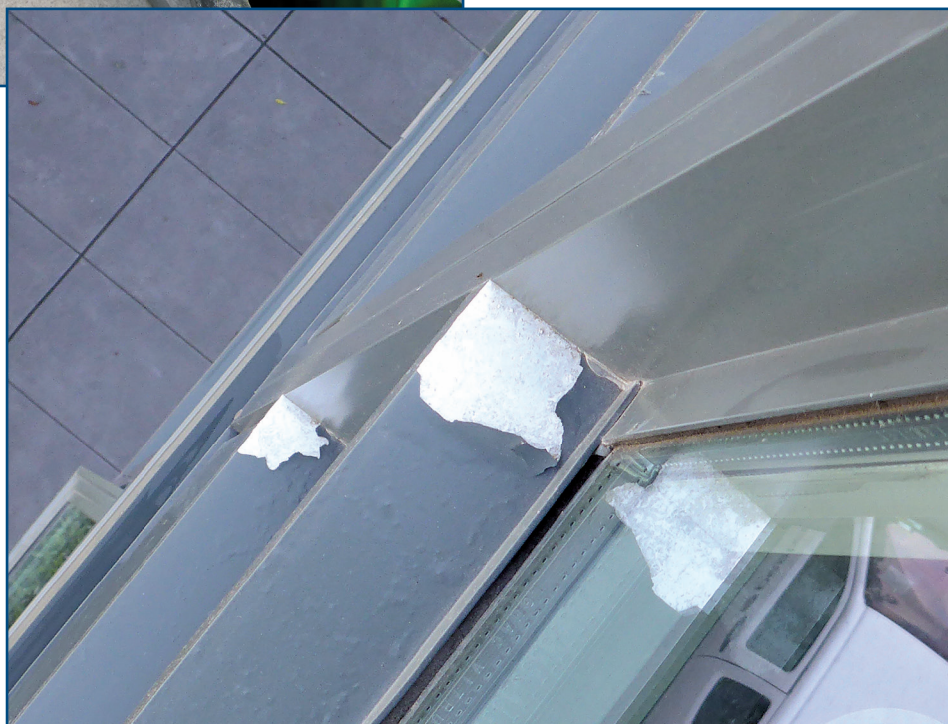
Figure 12 – Example of paint failure.

Figure 13 – Example of paint failure.

There are several architectural-grade paint finishes available on the market, but we typically recommend fluoropolymer paint finishes (like Kynar) that meet AAMA 2605 certification. But like all paint, even Kynar-based paint finishes need proper preparation and application to perform as intended (see *Figures 12 and 13*).

Paint failures are relatively infrequent when compared to some of the other failure modes in window-wall and curtainwall systems, but remediation of failures is particularly difficult. Often, the failure is related to lack of or inadequate pretreatment or where primers are part of the application but were improperly applied to the base metal being painted.
