# 30<sup>th</sup> RCI International Convention and Trade Show

## GLAZING FAILURES AND WAYS TO PREVENT THEM

**BRIAN HUBBS, PENG, AND JAMES HIGGINS**

*RDH BUILDING ENGINEERING LTD.*

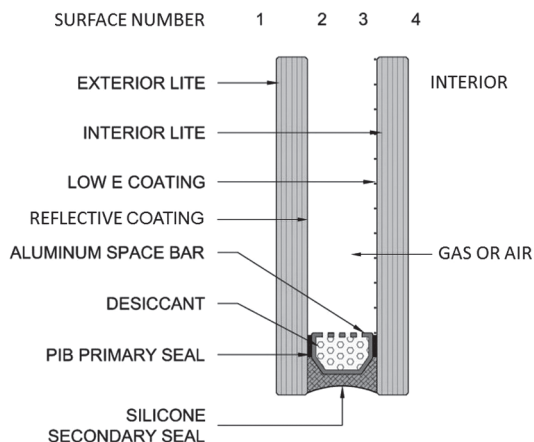
**Figure 1 – Conventional dual-sealed IGU.**

An IGU is made of two to three layers of glass, with reflective metallic and low-e coatings on various surfaces. The glass is held in place and sealed together with edge spacers and sealant, and the cavities between the glass lites are filled with various gasses such as argon (see *Figure 1*). The edge spacer is filled with desiccant in order to keep the airspace within the sealed unit free of moisture.

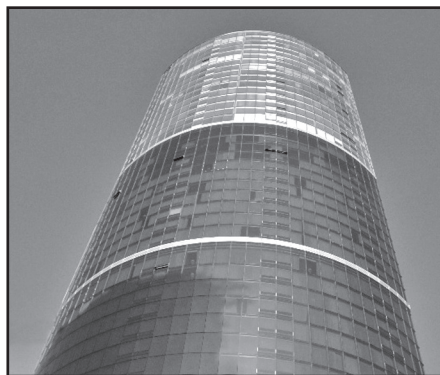
The 48-story building is a hotel and multiunit residential tower with a hotel on the first 31 floors and condominiums on the upper 17 floors. The building is completely clad with structural silicone-glazed (SSG) unitized curtain wall. The residential floors used a silver low-e coating on surface #2, while the lower hotel floors utilized a stainless steel coating, giving the building a two-tone color (*Figure 2*).

**Figure 2 – Building elevation showing two-tone curtain wall.**

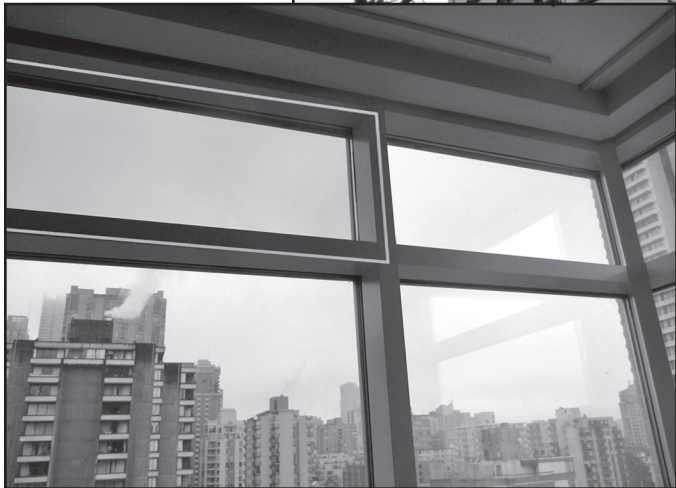
**Figure 22 – Glazing in Figure 21 viewed from the interior.**

competitive; in addition, it will be more likely that matching replacement glass will be found in the future. Figures 21 and 22 show an example of a building where the original glass tinting and color could not be matched by a replacement IGU.

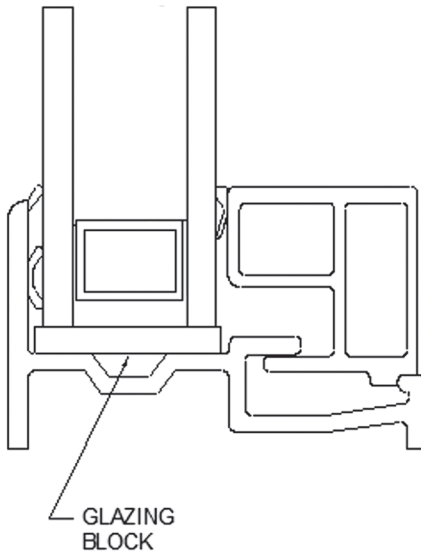
**Figure 29 – Typical legacy window system designed for double-glazing from IGMA TM1500.**

With the more frequent specification of triple glazing, even support of glazing lites can often be difficult with legacy framing systems that have been designed around thinner double glazing (Figures 29 and 30). It is important to check to ensure specified glazing streams can support the use of triple glazing installed in accordance with IGMA TM1500 before selecting a glazing manufacturer.
