### **TECHNICAL SERVICE BULLETIN**

# Compatibility with Insulating Glass Sealants

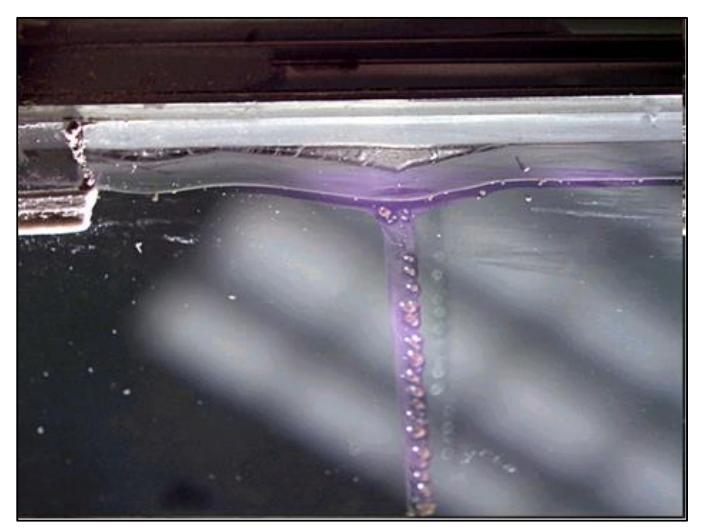
Organic plasticizers can attack the PIB primary seal of the IG unit. Symptoms of this attack, include slumping of the PIB material into the airspace, spacer read-through, and in severe cases separation of the PIB resulting in clear thick liquid inside the IG unit (see Figure IG15-01). Most organic plasticizers are not volatile and require direct contact between the material containing the plasticizer and the IG edge seal for migration to occur.

Figure IG15-01, Close up of liquid inside due to incompatible chemical attack of the PIB primary seal.

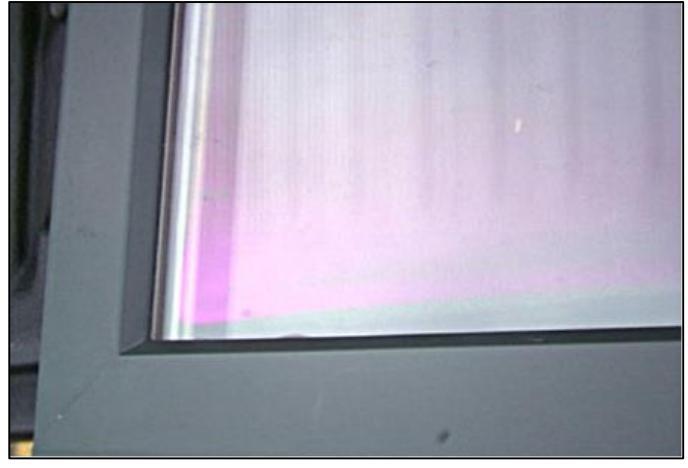
Most window lineal parts are treated by dipping the wood for a brief time into a tank containing the wood preservative solution. The window lineal parts are then moved to an area for drying where typically most of the solvents will evaporate. However, if the drying process is curtailed prematurely, or if the lineals are permitted to remain in the treatment tank for an extended period of time, solvent can remain in the lineal parts. In the tightly sealed reglet of a wood sash, the remaining solvent can volatilize and subsequently attack the insulating glass sealants.

Figure IG15-02 Photograph of chemical fogging on the LoE surface of the IG unit. Solvent vapors result in a purple color when viewed in reflection

To reduce the chances of chemical attack by wood preservatives, Cardinal recommends window manufactures ensure complete drying of their window lineal parts prior to glazing.
